Demonstration Truck Program 6. Field Test of a
Quieted Ford CLT 9000 Heavy-Duty Diesel Truck

EPA 550/9-82-331F

Field
Test
of a
Quieted
Ford CLT 9000
Heavy-Duty
Diesel Truck

October 1981

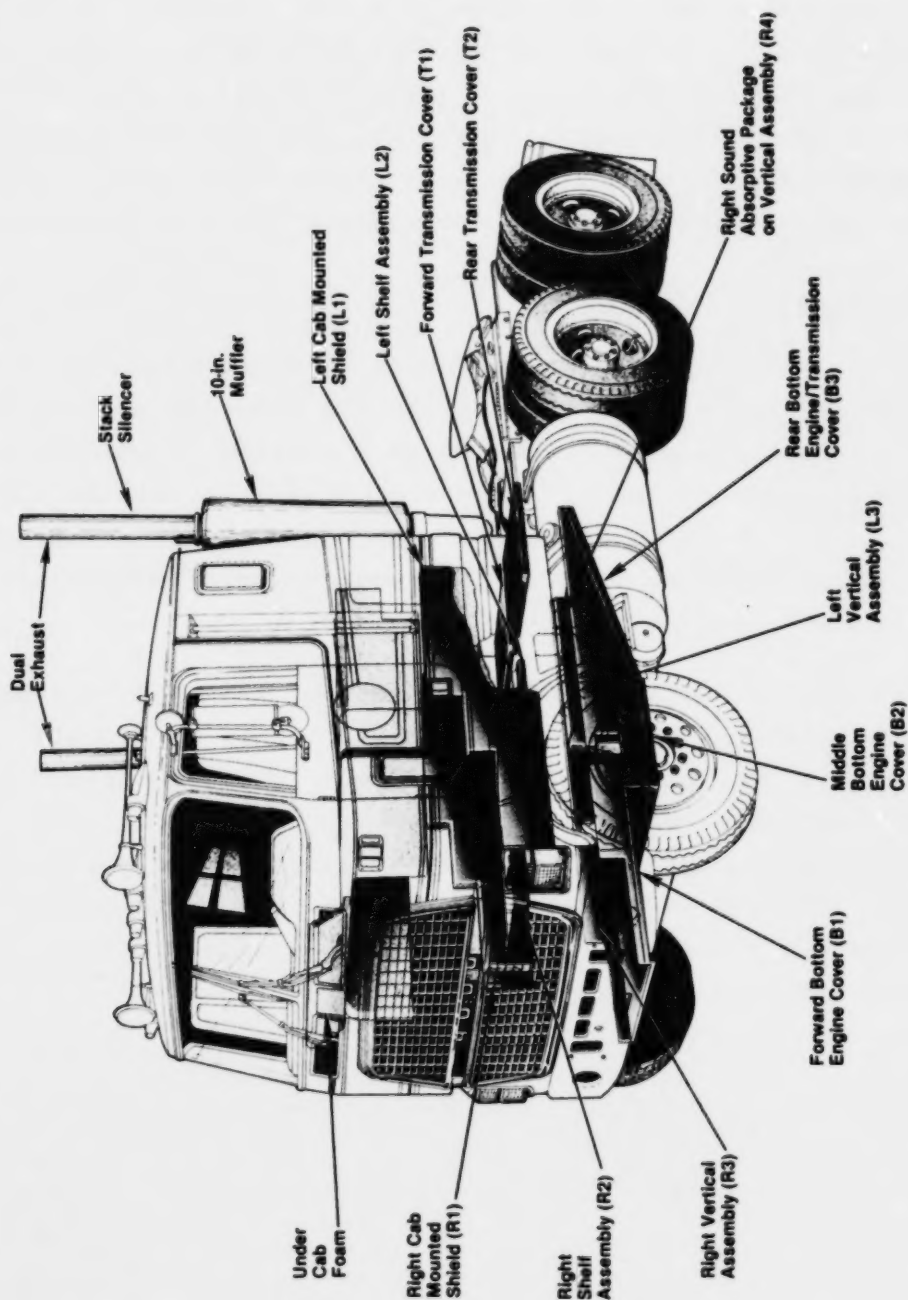
FIG. 3. NOISE CONTROL TREATMENTS INSTALLED ON FORD CLT 9000.

A minor modification to the rear spring bracket was also made. Figure 3 is a graphic representation of the BBN treatments.

exhaust line, consisting of aluminized steel tubing and stainless steel flex hose, leads from the turbocharger to the Splitter Tee Can. The Tee Can provides some muffling and splits the flow into dual 4-in. exhaust lines. Each line contains a nominal 10-in.-diameter double shell cylindrical muffler and a 4-in. stack silencer. The stack silencer has a 3-in.-diameter perforated liner made of aluminized steel, fiberglass packing, and a pressure recovery cone at the outlet. Note that it was necessary to add a stock exhaust stack mast to accommodate the dual system.

As shown in Fig. 3, the enclosure is a tunnel-like structure leading from the radiator to the rear of the cab. As much of the existing cab and chassis structure as is practical is used to form this structure. Spaces between the cab and top of the frame rails are filled in with side shields and shelves, and a bellypan extends from one frame rail, under the engine and transmission, to the opposite frame rail.

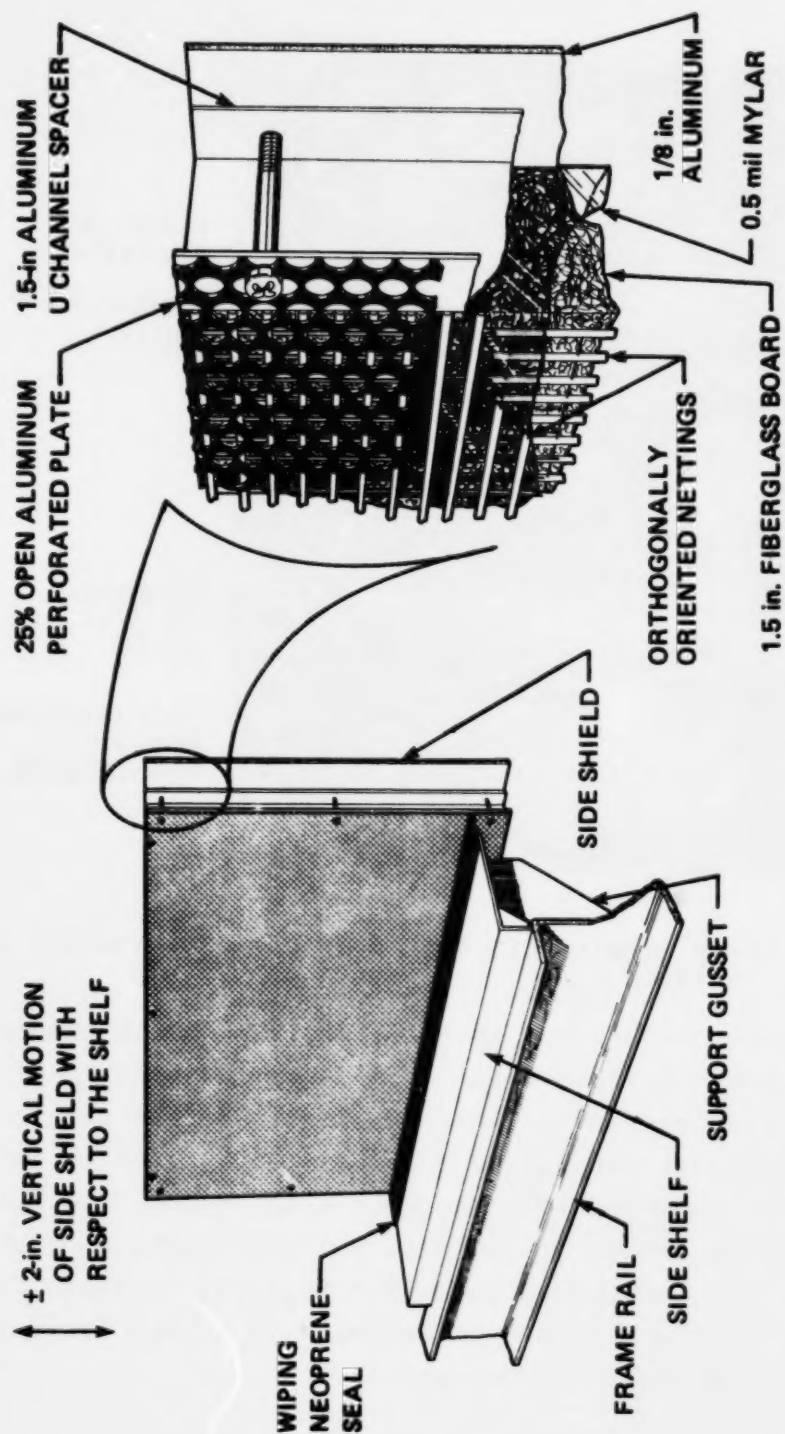
FIG. 5. ILLUSTRATION OF SIDE SHELF ASSEMBLY AND DETAILS OF CONSTRUCTION OF SOUND ABSORPTIVE MATERIAL.

Figure 5 shows how the side shelf assembly connects the side shield with the frame rail. The assembly consists of a shelf, several support gussets, and a wiping neoprene seal. The shelf and gussets are fabricated from 0.160-in. aluminum and are sturdy enough to stand on. The neoprene seal is designed to accommodate the vertical motion of the side shield, which moves with the pneumatically suspended cab. The bellypan assembly consists of two side panels that extend downward from each frame rail and are connected by three bottom panels.

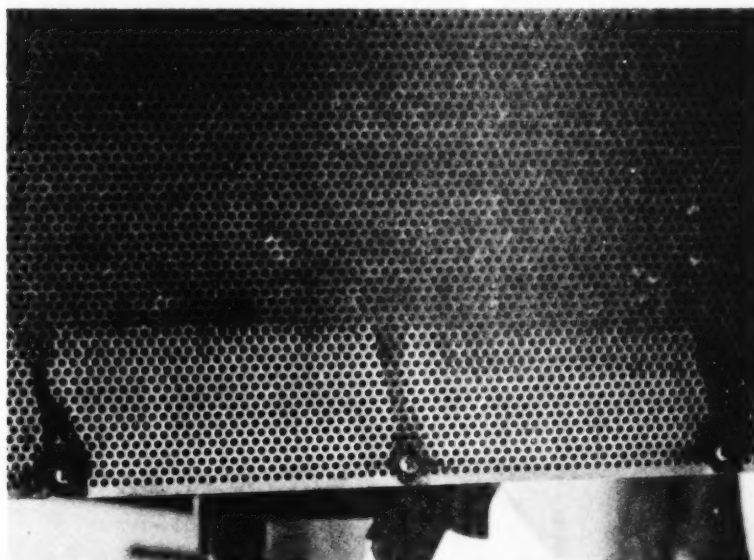
FIG. 15. LEFT SIDE SHIELD POLISHED BY NEOPRENE WIPING SEAL.

A closer view of the left shield shows that a strip about 3 in. wide along the bottom edge of the shield has been polished and left shining by the neoprene wiping seal (Fig. 15). The heads of the sheet metal screws used to fasten the perforated metal are clearly visible in this photograph. Figure 16 shows that these screw heads wore grooves in the left wiping seal. The right wiping seal exhibits even more wear, as illustrated in Fig. 17.

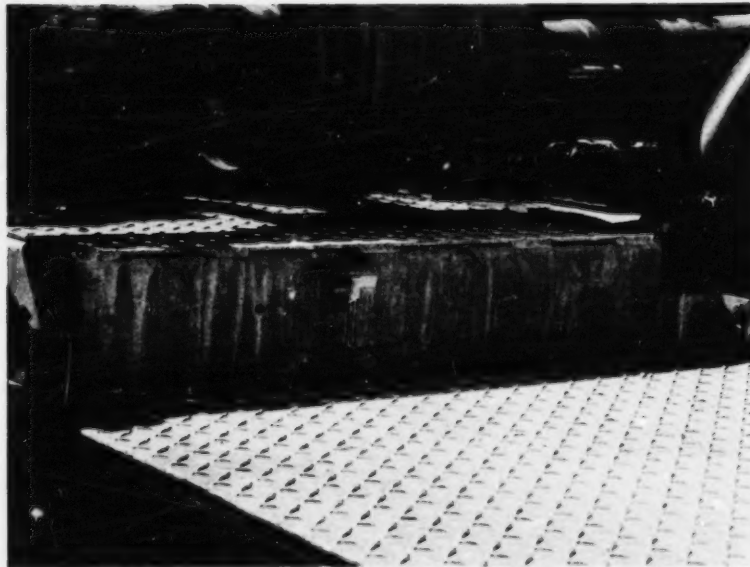
FIG. 19. REAR AND FORWARD PORTIONS OF THE TRANSMISSION COVER.

The transmission cover held up well during the test. Figure 19 shows the rear and forward portions of the cover. Two of the upper cover brackets are illustrated in this figure. A close-up of the left bracket (Fig. 20) shows that it is intact. A similar view of the right bracket in Fig. 21 shows a gap where a shim had apparently not been reinstalled after servicing.

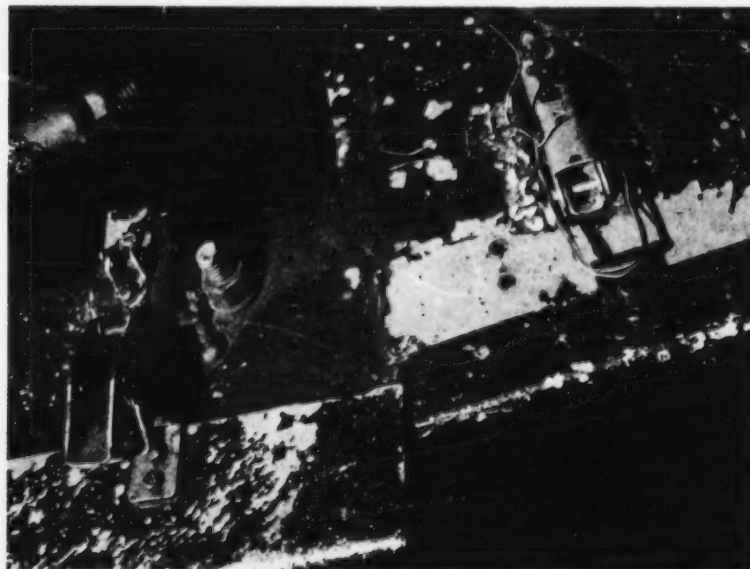
FIG. 22. FAULTY LATCHES ON THE BOTTOM ENGINE COVERS.

Figure 22 illustrates some problems that developed with the latches on the bottom engine covers. The latch at the left did not align properly with the keep and remained unfastened. The bail was missing from the right latch and was replaced by ordinary wire.

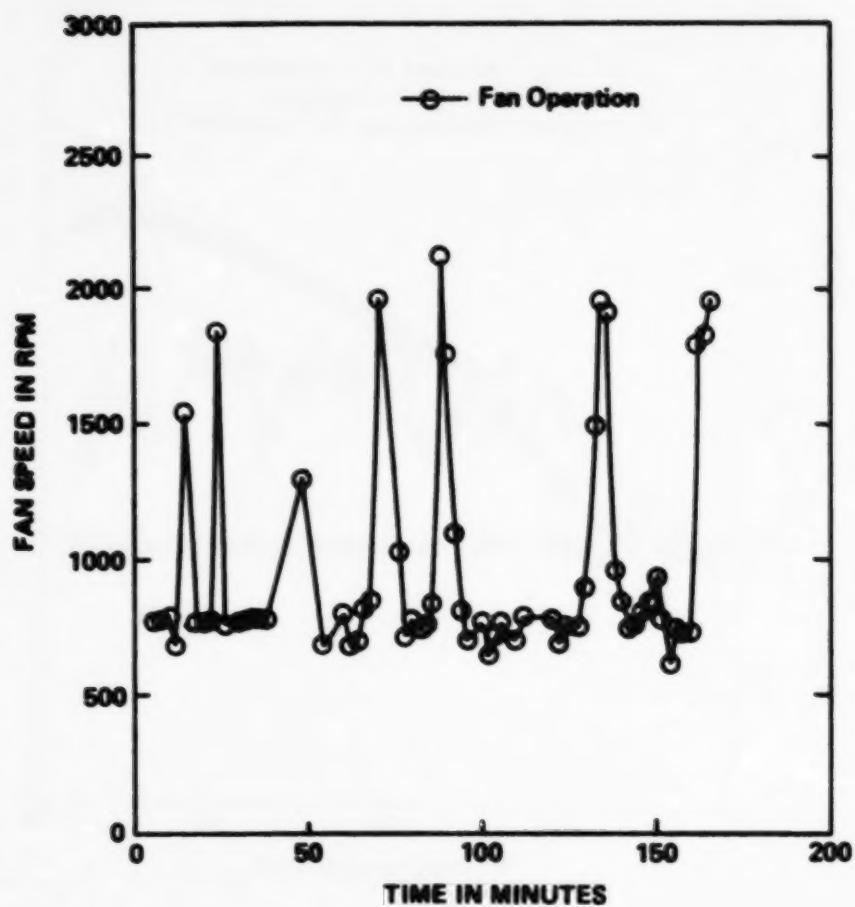
FIG. 25. ROAD TEST OF FORD CLT 9000 WITH ACOUSTICAL PANELS.

Figure 25 shows the fan speed as a function of time from the start of the outbound test. The fan is activated occasionally but spends most of the time idling at about 700 to 800 rpm. Figure 26 shows ambient, fan outlet, and transmission oil temperatures vs time. The ambient was 97.5°F at the start of the trip, reached a low of 92.7°F, and ended at 96.1°F. The transmission oil temperature required about 3 hours to reach a peak of 219°F and ended at 215.1°F. The fan outlet temperature ranged primarily from about 110°F to 170°F. The peak transmission oil temperature of 219°F is safely below the 250°F specification and well below the reported 275°F.

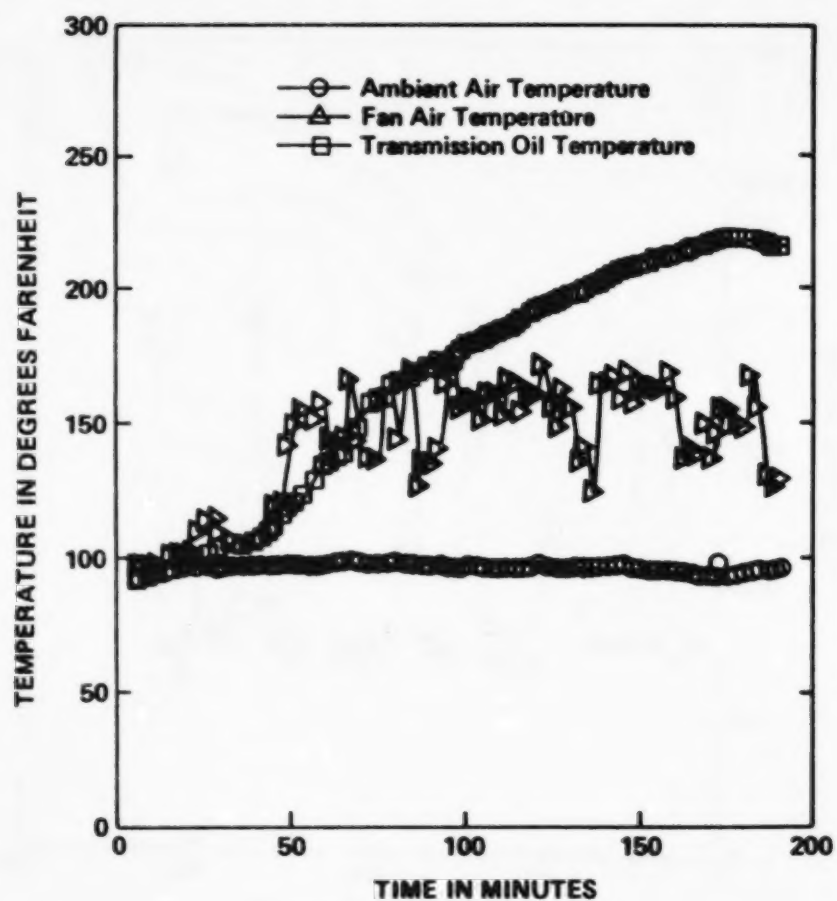
FIG. 26. TEMPERATURE TESTS OF FORD CLT 9000 WITH ACOUSTICAL PANELS.

We conclude that the engine and transmission enclosure was not the cause of the 275° transmission oil temperature. The test results show that while the enclosure did increase the oil temperature, the increase was well within the manufacturer's specification.

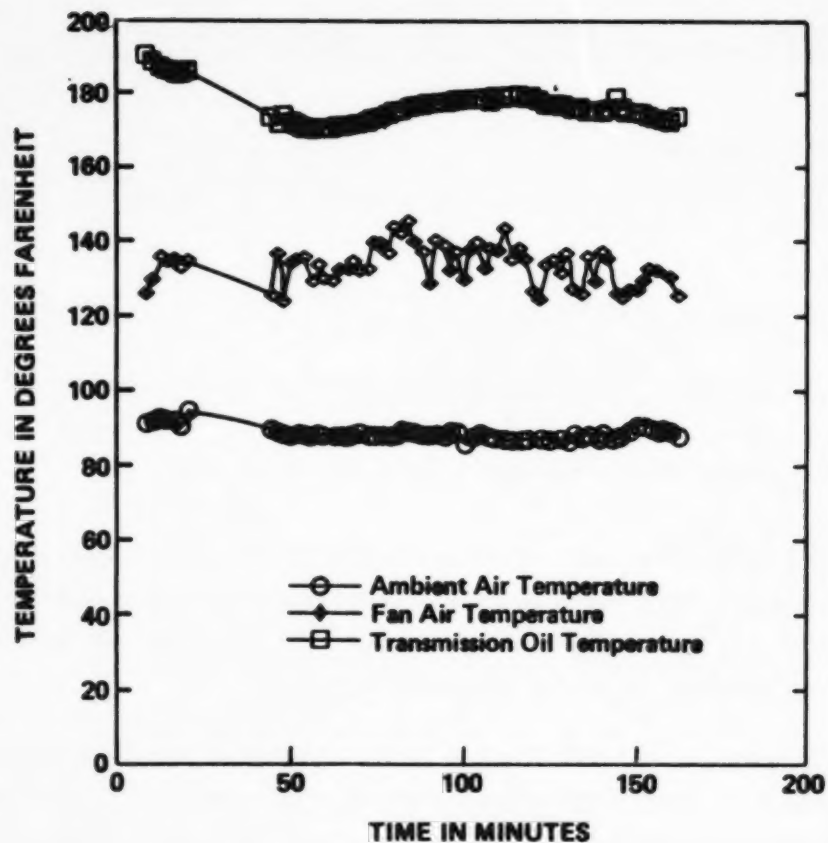
FIG. 27. ROAD TEST OF FORD CLT 9000 WITHOUT ACOUSTICAL PANELS.

Figure 27 is a graphical summary of the return trip (Test 2) showing ambient, fan, and transmission oil temperatures. The transmission oil temperature stabilized at about 177°F, at an ambient temperature of about 88°F, and at a fan air temperature of 135°F.

In a worst-case comparison, with acoustic panels in place, under load, in a heat spell, the maximum transmission oil temperature was about 217°F. This temperature was 40°F warmer than that for an unloaded truck, operating without acoustical panels, in an environment that was 8°F cooler ambient, and 19°F cooler behind the radiator (presumably because of a lighter load and

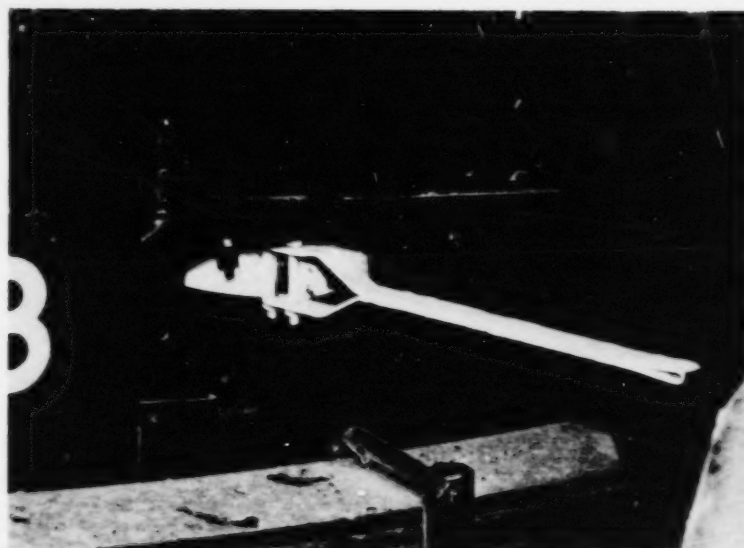
FIG. 33. OIL FILTER WRENCH INSERTED THROUGH ACCESS PORT IN ENCLOSURE.

Figure 33 shows a filter wrench on the oil filter. The wrench is inserted through an access port in the right vertical assembly below the frame rail. When the filter is loosened, a mechanic reaches it from under the vehicle and removes it by hand. The procedure is reversed for filter installation. In this case, the treatment does limit access.
